# INFORM

INFORMATION FOR HISTORIC BUILDING OWNERS

## Masonry Decay

Dealing with  
the Erosion  
of Sandstone

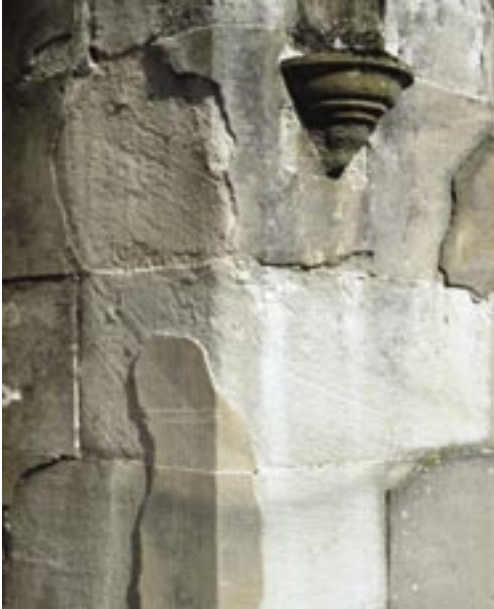
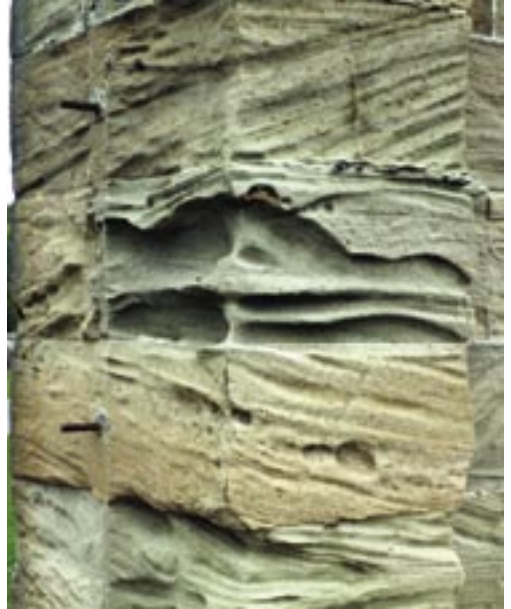
Stone decay manifests itself in many ways. This can lead to different appearances such as:

- A powdery surface of loose grains
- A separating skin (of different thicknesses)
- Penetrating holes, creating a honeycomb effect
- Open fractures crossing stones on unusual angles, or in a “starburst” effect
- Severe partial destruction of individual stones
- A white build-up of salt material on the surface
- Partial failure of projecting mouldings and carvings
- Blistered bubbles
- Deterioration of individual stones leaving the surrounding mortar standing proud
- A general blurring and loss of sharpness
- Tidemarks, water stains, and discolorations
- Wear patterns.

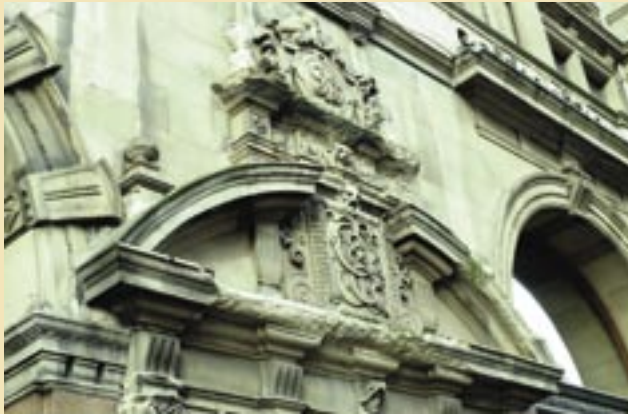
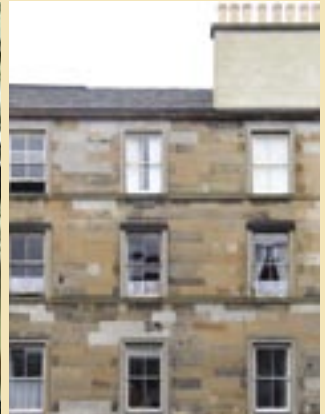
The stone cleaning problem has been compounded by the adoption of "plastic repairs" as an inappropriate maintenance technique. Here, a variety of synthetic mixtures have been spread onto the face of badly damaged stones in the misguided belief that they would improve the appearance and performance of the building. Over time the

use of these impervious “plastic” materials inevitably trapped water behind the patch. This has frequently led to the two materials failing where they were originally fixed together, and a number of incidents where the applied repair has subsequently fallen off the wall face, creating additional safety concerns. The applications of such synthetic materials are best avoided.
